古川の水質調査結果（D O）の経年変化グラフ

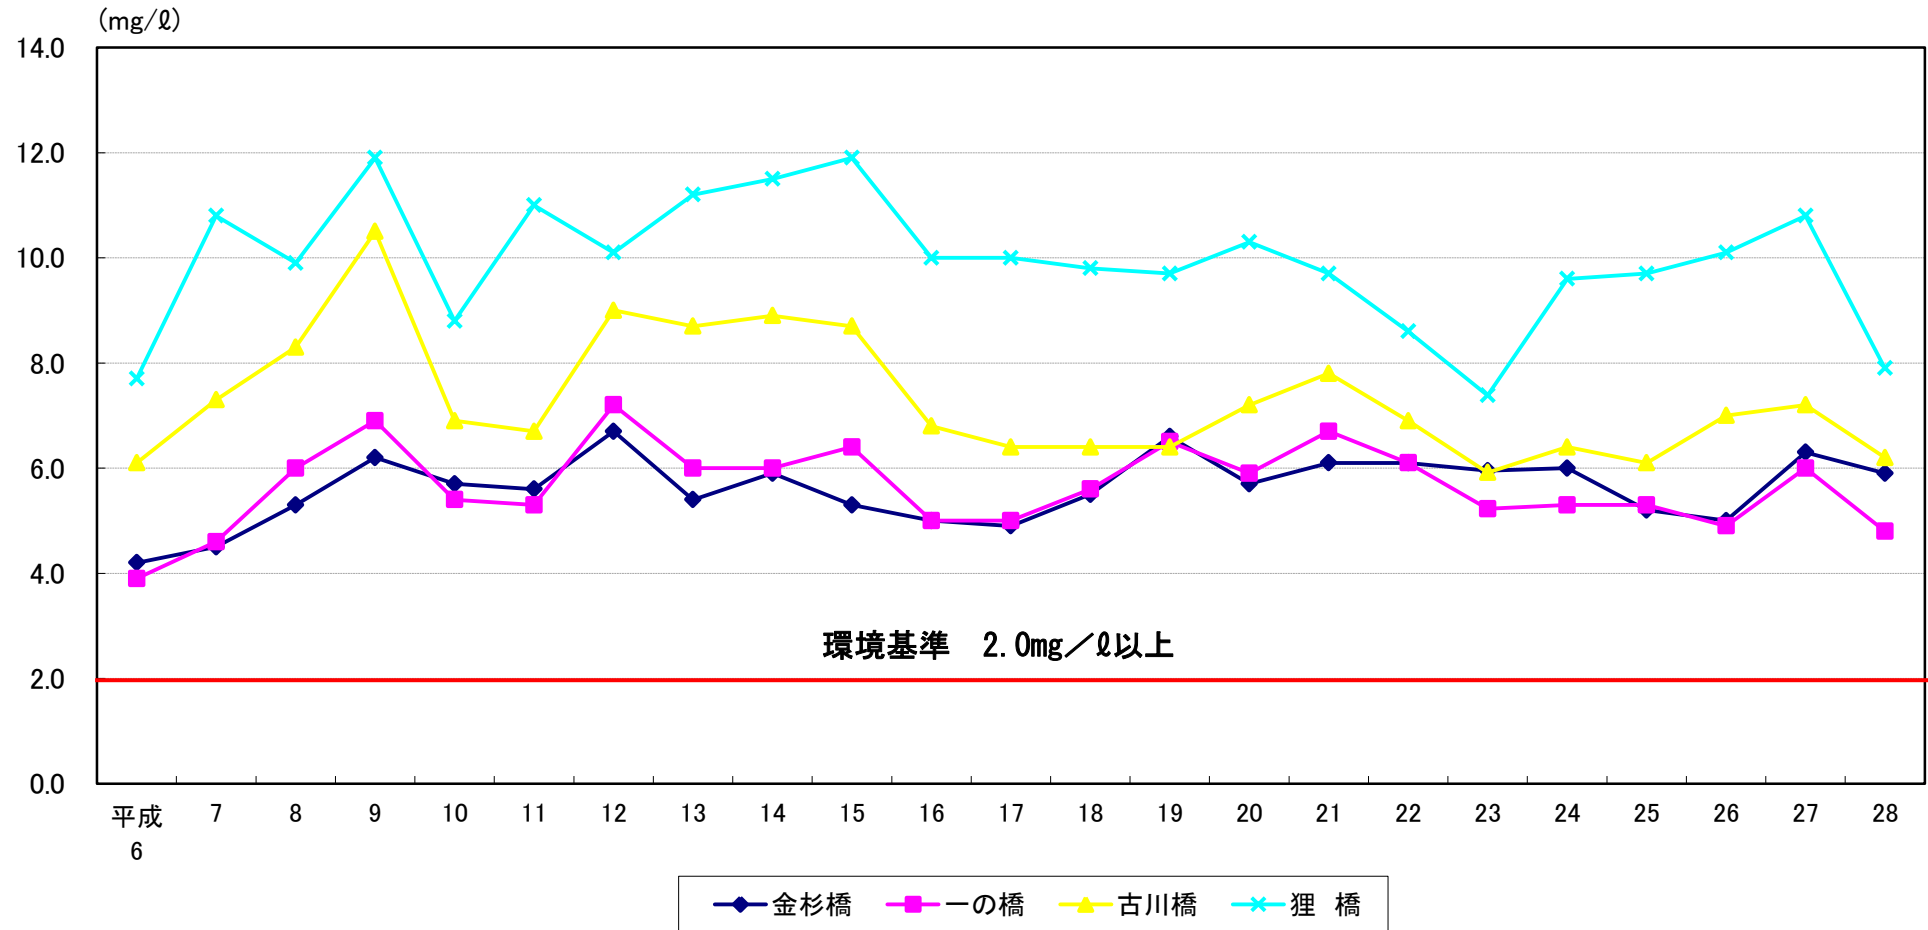
平成6	7	8	9	10	11	12	13	14	15	16	17	18	19	20	21	22	23	24	25	26	27	28
金杉橋	4.2	4.5	5.3	6.2	5.7	5.6	6.7	5.4	5.9	5.3	5.0	4.9	5.5	6.6	5.7	6.1	6.1	6.0	6.0	5.2	5.0	6.3	5.9
一の橋	3.9	4.6	6.0	6.9	5.4	5.3	7.2	6.0	6.0	6.4	5.0	5.0	5.6	6.5	5.9	6.7	6.1	5.2	5.3	5.3	4.9	6.0	4.8
古川橋	6.1	7.3	8.3	10.5	6.9	6.7	9.0	8.7	8.9	8.7	6.8	6.4	6.4	6.4	7.2	7.8	6.9	5.9	6.4	6.1	7.0	7.2	6.2
狸橋	7.7	10.8	9.9	11.9	8.8	11.0	10.1	11.2	11.5	11.9	10.0	10.0	9.8	9.7	10.3	9.7	8.6	7.4	9.6	9.7	10.1	10.8	7.9
